Technical Report REMR-CS-53  
April 1997

*Repair, Evaluation, Maintenance, and Rehabilitation Research Program*

# **Applications of Roller-Compacted Concrete in Rehabilitation and Replacement of Hydraulic Structures**

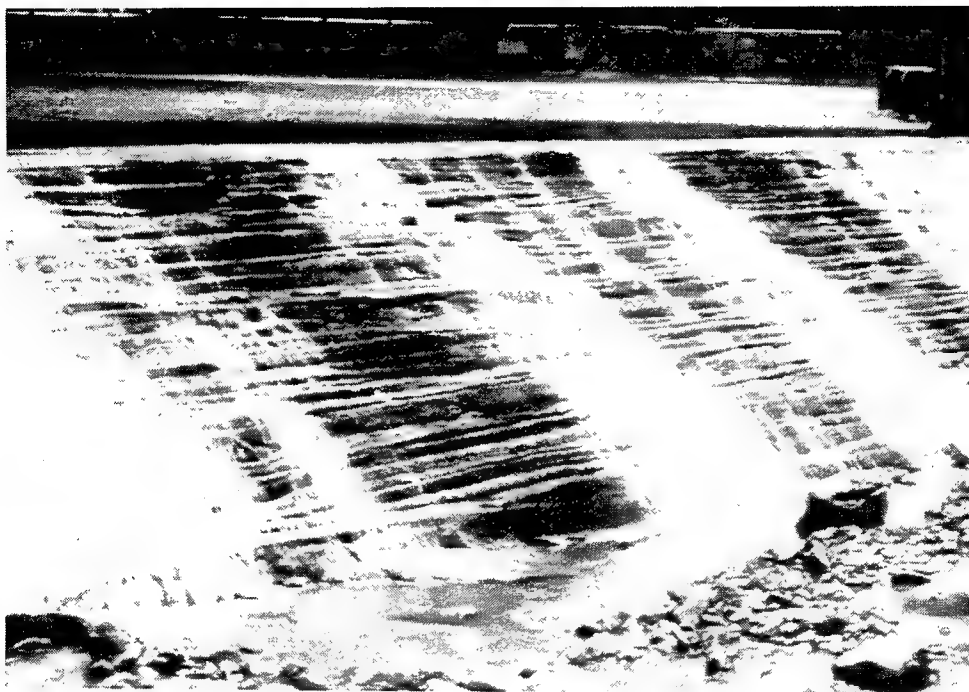
After more than 1,000 overtoppings of the rehabilitated structure, including a 3.7-m (12-ft-) depth of flow during a flood in early 1990, the RCC remains in good condition (Figure 2). Except for some erosion of poorly compacted RCC at the downstream toe, the RCC has not been damaged by water and weathering.

**Figure 2. Downstream face of Ocoee Dam with RCC overtopping protection**

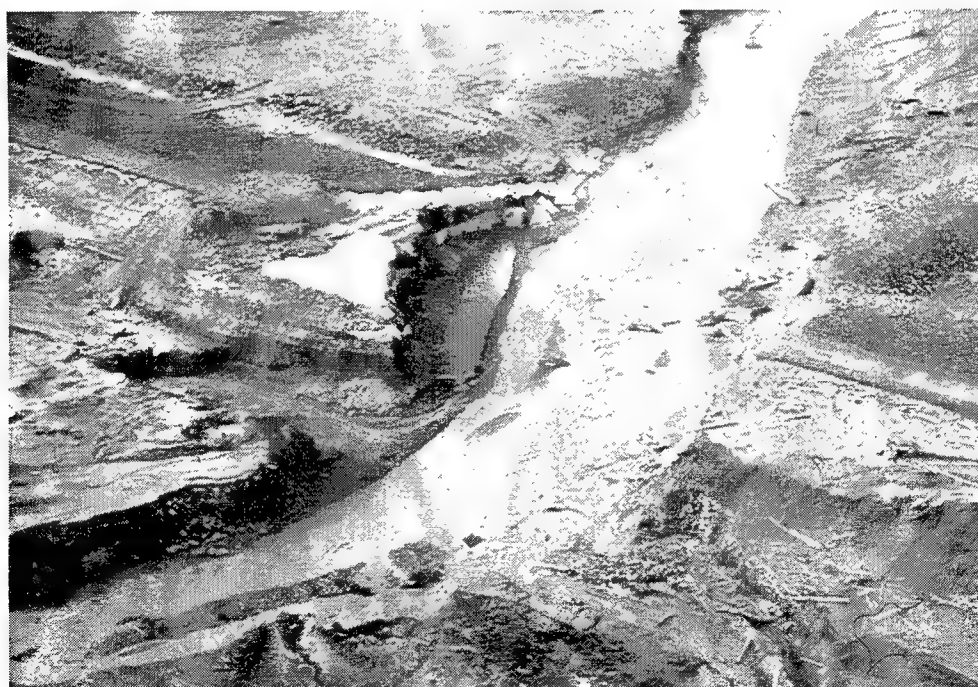
structure was 1 month old, the spillway had failed because of erosion caused by high flows and debris (Figure 3).

**Figure 3. Failed gabion spillway, Toutle River**

The USACE needed a quick and economical method for replacing the spillway before debris blocked the channel. Steel mesh-reinforced RCC was the option selected. The replacement spillway was 91.4 m (300 ft) wide with a 36.6-m- (120-ft-) long downstream apron. It had a horizontal crest and a downstream slope of 1:4 (Hansen 1989a).

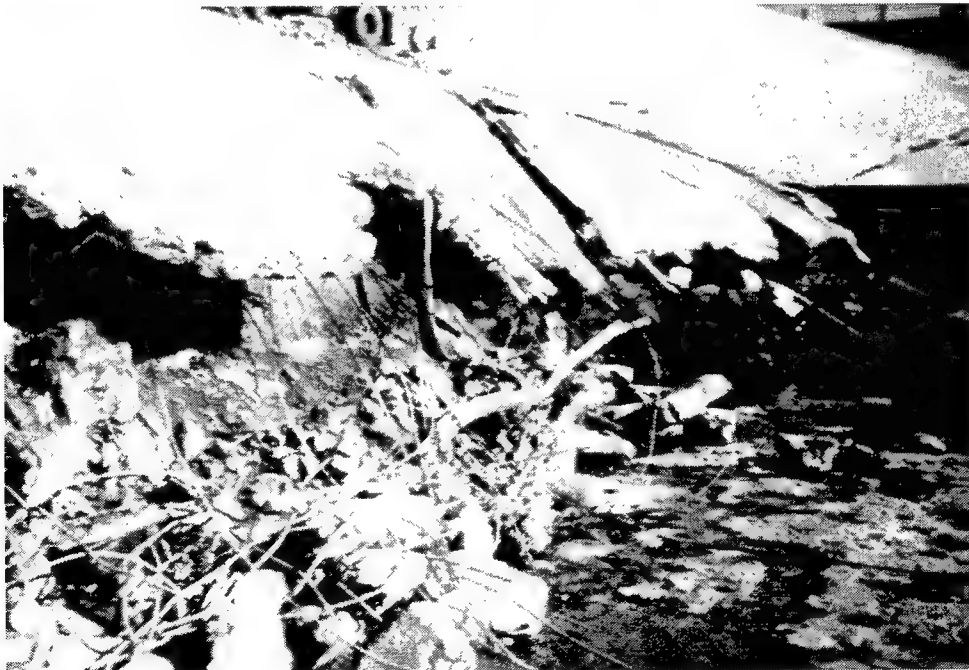
The dam was overtopped by 1.2 m (4 ft) in June 1981, when it sustained some damage. It was overtopped again in October 1982 by 1.4 m (4.5 ft); this time damage was more severe. Then on New Year's Eve 1984, the dam was overtopped by 3.0 m (10 ft). Damage included a loss of about 40 percent of the concrete shell over the service spillway and about one-half of the downstream embankment, severe concrete cracking in the emergency spillway, loss of filter material, and erosion in both abutments (Figure 8). The clay core was eroded to bedrock (Smith 1986).

**a. Overall view of dam**

**b. Closeup view of spillway damage**

**Figure 8. Overtopping damage to service spillway, Kerrville Ponding Dam**

Several alternatives, including repair of the existing structure, were evaluated, but design engineers and consultants determined the fastest and most economical solution was to construct a new RCC section on the downstream embankment (Figure 9).

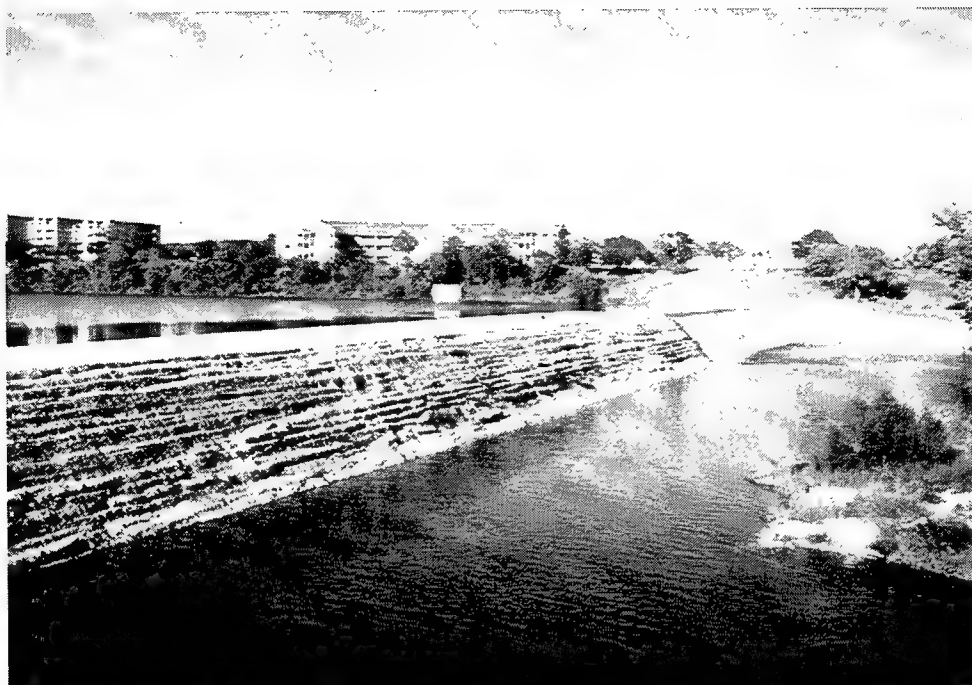
In October 1985, about a month following completion of RCC placement, a 279-mm (11-in.) rain caused a once-in-50-years flood. The new RCC gravity section was overtopped by 4.4 m (14.4 ft), and the emergency spillway by 4.1 m (13.4 ft). At its crest, the flood reached a flow of 3,540 cms (125,000 cfs) over the dam (*RCC Newsletter* 1986). Water flowed over the entire dam for about 5 days and over the service spillway for 3 weeks. An inspection of the dam following the flood revealed significant erosion in the uncompleted earthen abutments; however, damage to the RCC was limited to some minor surface spalling (Figure 11).

Figure 11. Condition of the RCC following overtopping, Kerrville Ponding Dam

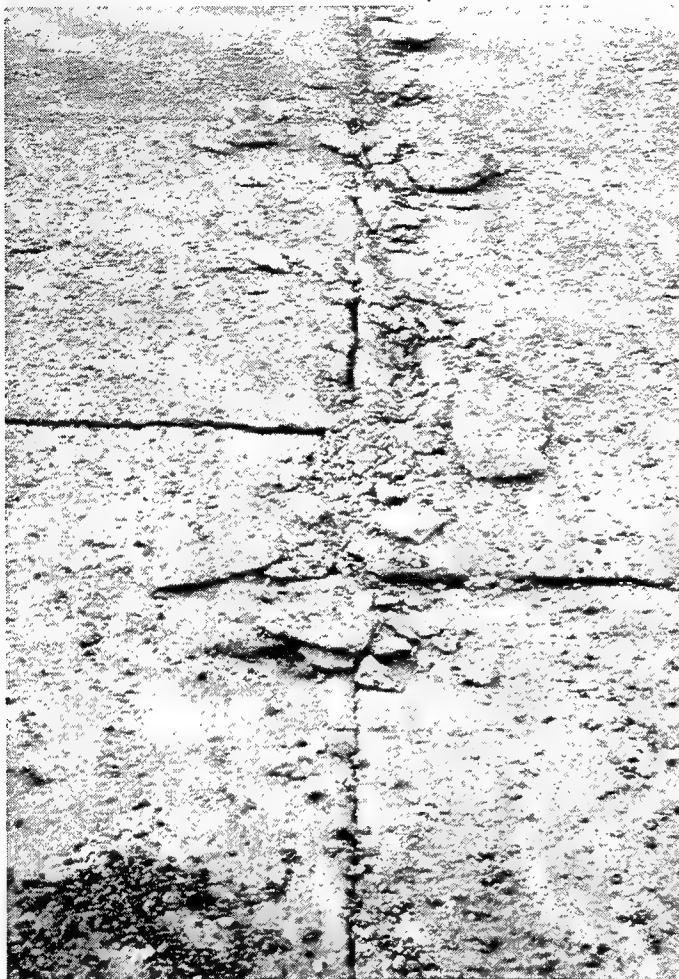
In general, depth of spalling was a maximum at a crack or joint and decreased to a featheredge within 0.3 to 0.6 m (1 to 2 ft) perpendicular to the crack or joint (Figure 16).

Figure 16. RCC spalling along a joint, Addicks Dam

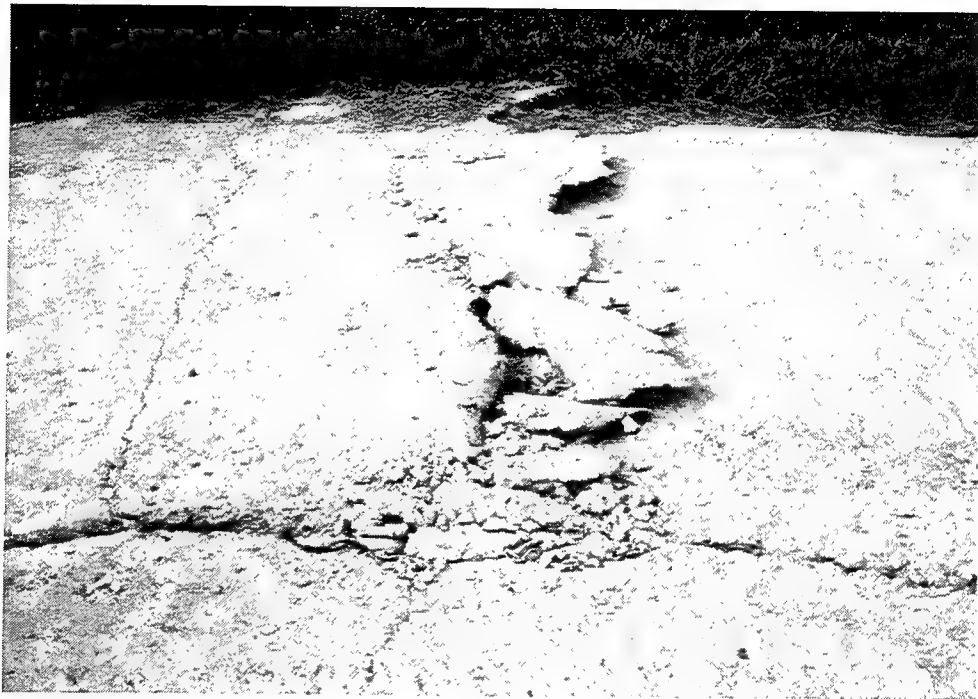
**Figure 17. Buckling blowups in RCC at Addicks Dam**

A contract for the repairs to the RCC was awarded in 1990. Approximately 290 sq m (350 sq yd) of concrete was used to repair areas damaged by spalling and buckling. The repair mixture was proportioned to have an average compressive strength of 20.7 MPa (3,000 psi) and a slump of no more than

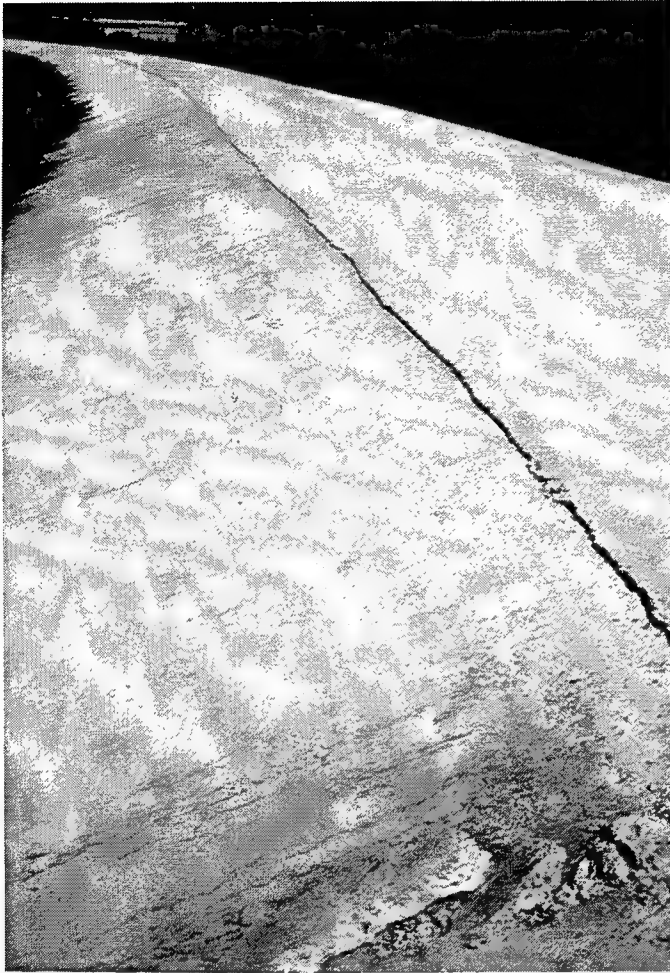
Longitudinal separations between the crest and facing lanes (Figure 18) occurred at both dams. The wider separations, averaging about 25 mm (1 in.),

**Figure 18. Typical separation of crest and slope at Addicks and Barker Dams**

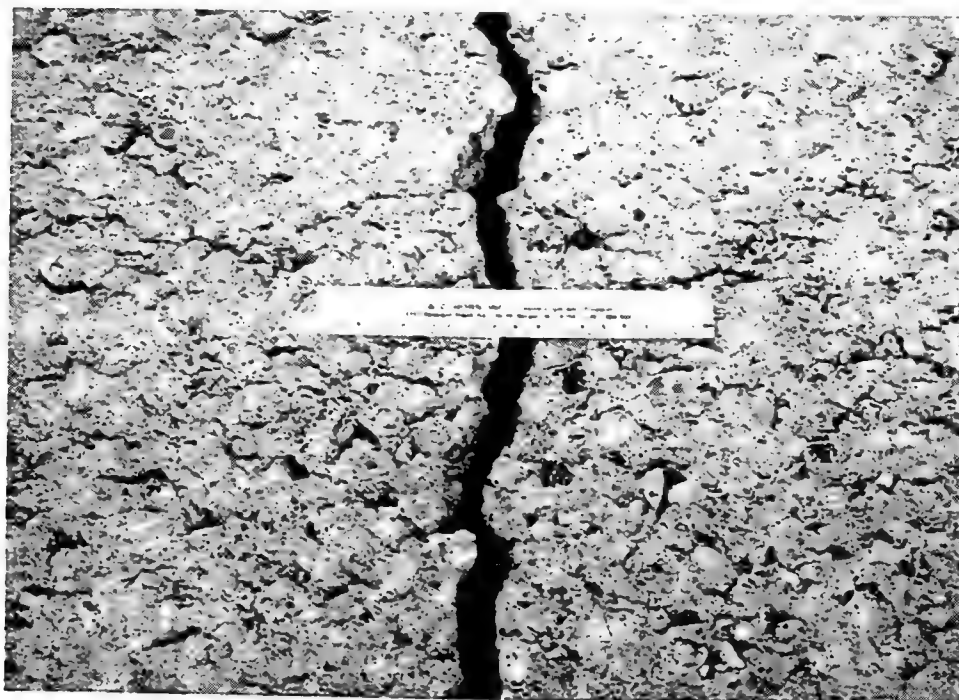
**Figure 19. Longitudinal crack in the RCC armorplating at Addicks Dam**

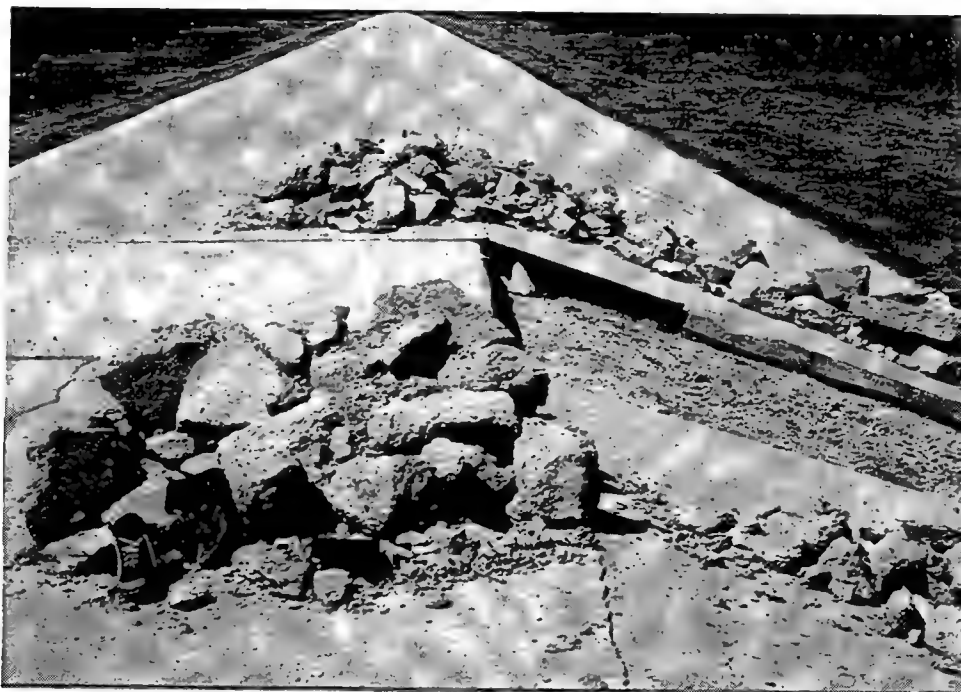
**Figure 20. Removal of spalled RCC and replacement with new concrete, Barker Dam**

76 mm (3 in.). Each cubic yard contained a minimum of five bags of portland cement and 5 percent entrained air. Repair areas were identified by sounding cracks and construction joints to locate delamination or spalling. Spall repair involved removing and replacing damaged concrete (Figure 20). Repair

boundaries were extended beyond the spalled areas. The sides of the repair area were vertically saw cut a depth of 51 mm (2 in.). Damaged concrete was removed down to sound, unweathered concrete, and the repair surfaces were cleaned with brooms and compressed air. Any areas that were contaminated with oil or grease were sandblasted. Epoxy-resin adhesive was used to bond the replacement concrete to the existing RCC (Figure 21).
